Manhole Inspection Summary

Manhole # S29U1_001MH

Insp Date: **5/1/08 1:12 PM**

Location Address: **601 W. Patapsco Ave.**

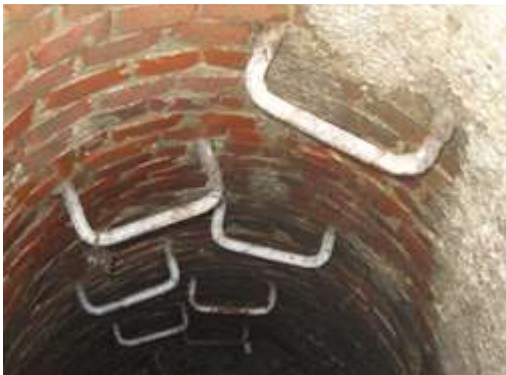
Steps

Count: **7** Missing: **0** ☒ **Corroded**

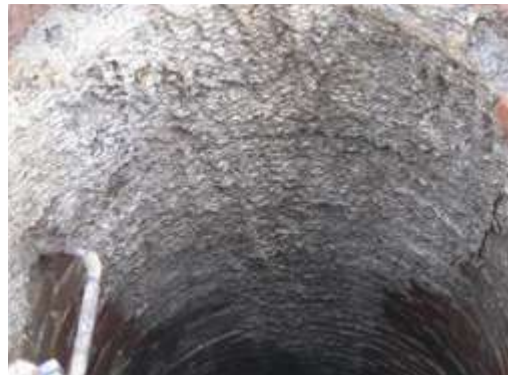
Defect 2

Infiltration: ☐ None ☒ **Joint** ☐ Cracks ☐ Mortar ☐ Roots ☒ **Wall**

Infiltration: ☐ None ☐ Joint ☐ Cracks ☐ Mortar ☐ Roots ☒ **Wall**

Infiltration

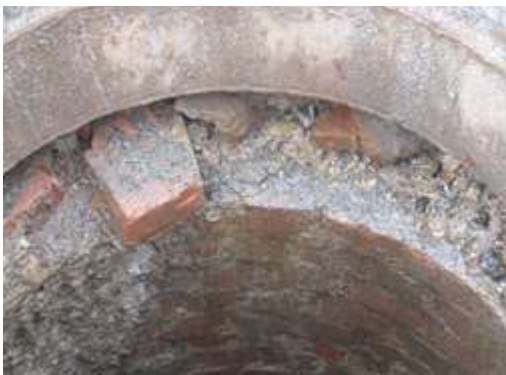
Defect 1

Offset: **2.5** (in.)

Condition: ☐ Sound ☐ Cracked ☐ Root Intrusion ☒ **Loose Brick** ☐ Deteriorated

Frame offset/loose bricks

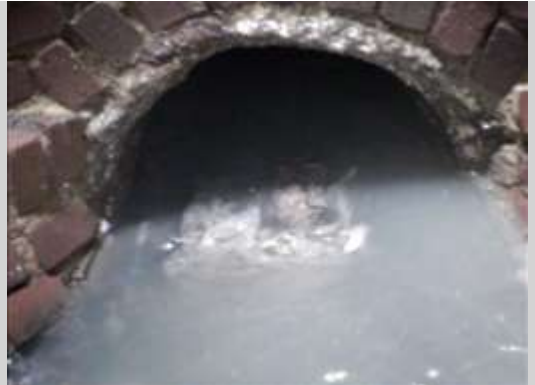
12 O'Clock Outflow

21 in. Circular Gravity Sewer
Pipe Out @ 12 O'Clock

Pipe Height: **21.6** (in.) Rod and Bar (Angled)
Pipe Material: **Concrete** ☐ Pipe Lined
Invert Depth: **14.12** (ft.) Flow Characteristics: **Fast**
Deposits: ☒ None ☐ Mud ☐ Sludge ☐ Debris ☐ Grease
Silt Depth: (in.) Deposits Extent:
Infiltration: **None** Pipe Seal Cond: **Sound**

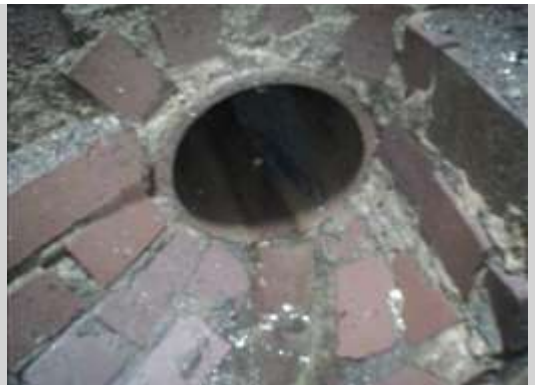
3 O'Clock Inflow

6 in. Circular Gravity Sewer
Pipe In @ 3 O'Clock

Pipe Height: **8.4** (in.) Rod and Bar (Angled)
Pipe Material: **Clay** ☐ Pipe Lined
Invert Depth: **12.86** (ft.) Flow Characteristics: **None**
Deposits: ☒ None ☐ Mud ☐ Sludge ☐ Debris ☐ Grease
Silt Depth: (in.) Deposits Extent:
Infiltration: **None** Pipe Seal Cond: **Sound**

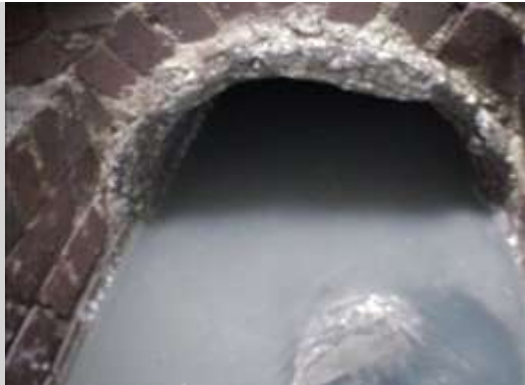
6 O'Clock Inflow

Pipe Height: **21.6** (in.) Rod and Bar (Angled)

Infiltration: **None** Pipe Seal Cond: **Sound**

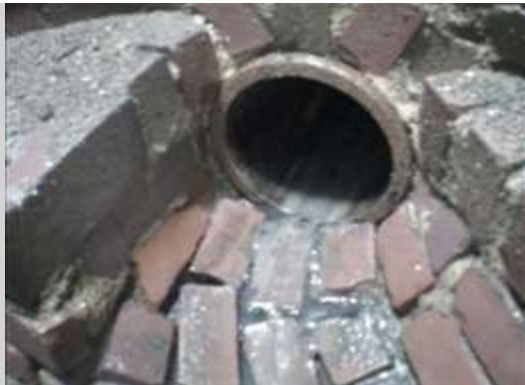
9 O'Clock Inflow

Pipe Height: **8.4** (in.) Rod and Bar (Angled)

Infiltration: **None** Pipe Seal Cond: **Sound**
